Mucky Marsh Mitigation Site (LRB-2019-00976)

Prepared by:
Ducks Unlimited Inc.
New York In-Lieu Fee Program
LRB-2010-00673 (ILFP)

Date: 23 June 2021

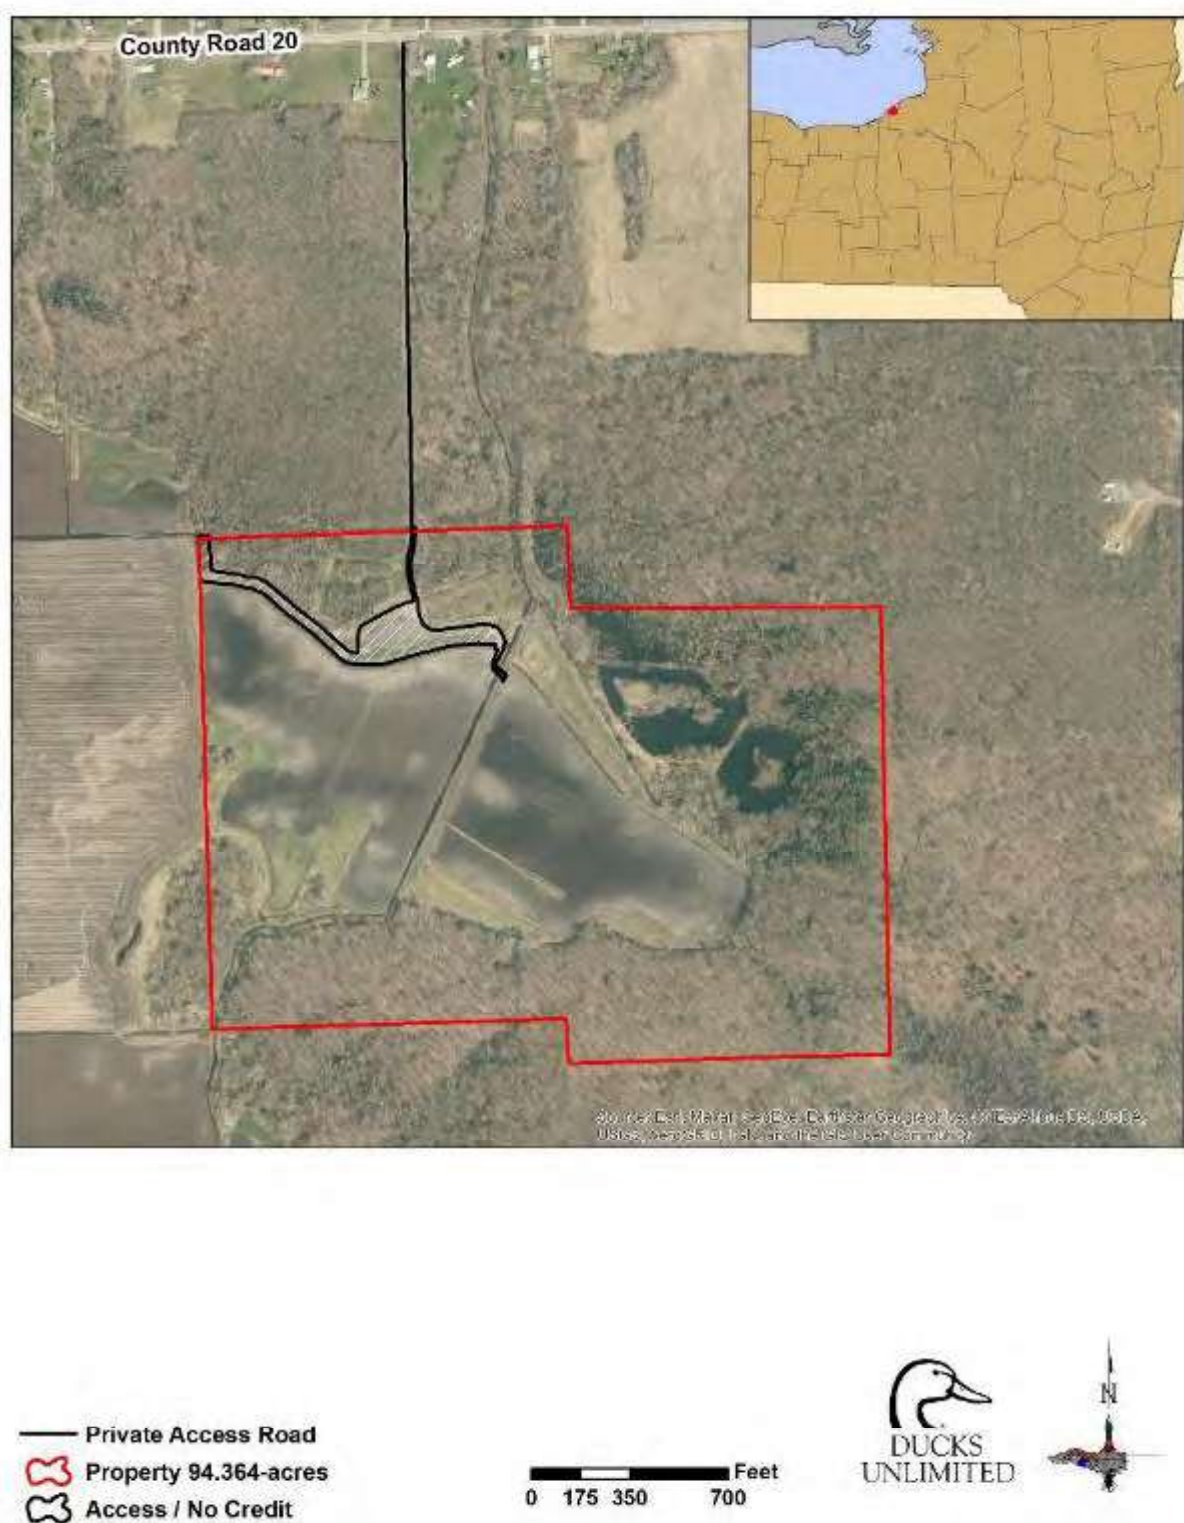
Figure 2 View of the Site.

The 94.364-acre Site is owned by Wetlands America Trust (WAT). WAT is a wholly owned subsidiary of Ducks Unlimited. Legal access to the property is from the north through a driveway that meets County Route 20 in Oswego, NY. An access/parking area is identified where soils are compacted or include gravel.

The geographic boundaries of the Site correspond to the 94.364-acre area to be placed under a conservation easement (red-line) as depicted in Figure 2, and in Appendix F. The Site lies to the South of Oswego of Route 20 in the town of Oswego, NY. A small area, excluded from the credit production, will serve as parking (Figure 2).

DU may contemplate entering a reciprocal Site Access and Flowage Easement (SAFE) with the neighboring muck farm property owner to the West of the Site for the West-East as depicted by the Access / No Credit area in Figure 2. While this potential SAFE does not appear to be explicitly necessary to ensure the success of the Site, nor required of DU, if executed, the agreement would enable the neighboring landowner some rights to maintain flows of the West-East ditch depicted in Appendix A to ensure positive relations. Any such agreement would be subject to USACE, WAT, and DU approval prior to execution.

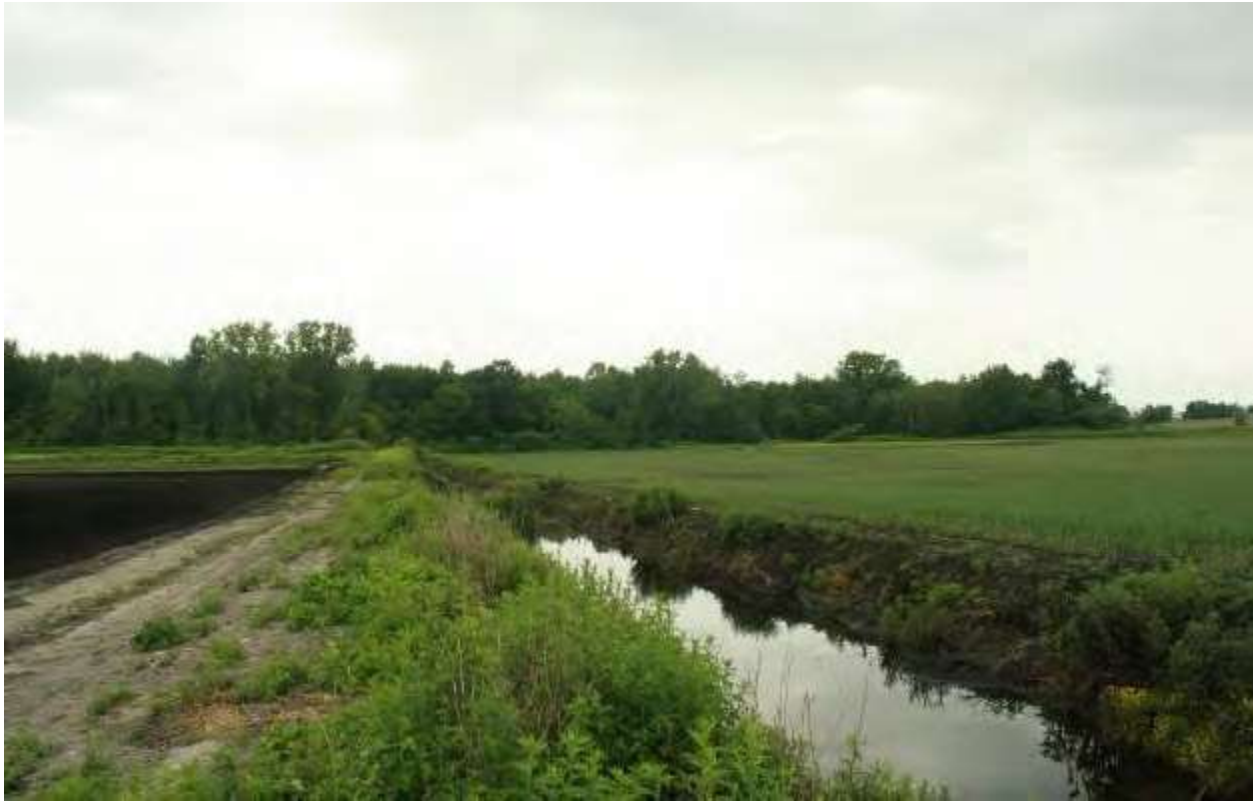
This is the channelized section of Snake Creek that runs through the middle of the property. July 2019.

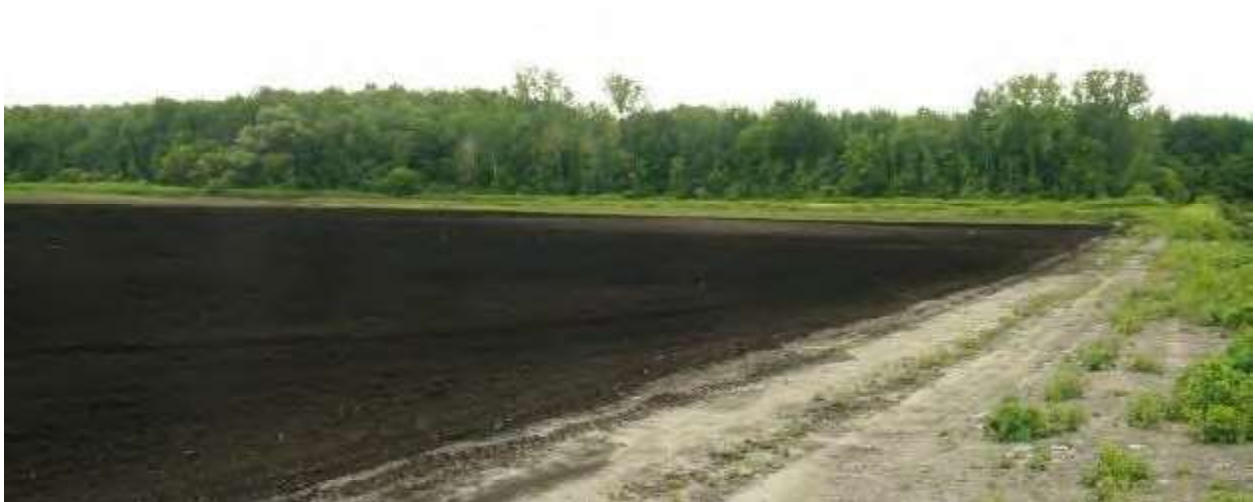
Looking east over the muck field that had been recently tilled. The dark soil is rich muck that is ideal for planting onions. July 2019.

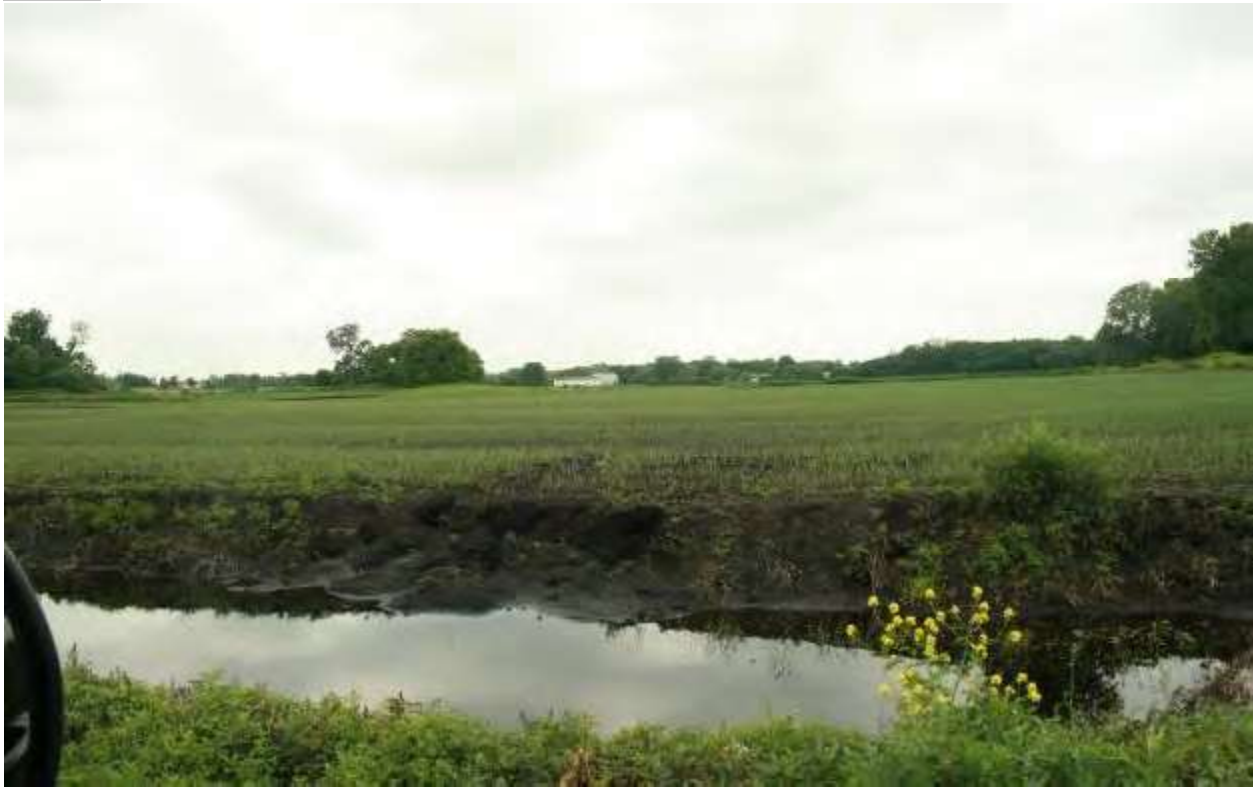
Looking across Snake Creek towards the western field. Onions can be seen growing on the site. July 2019. This side is well-drained.

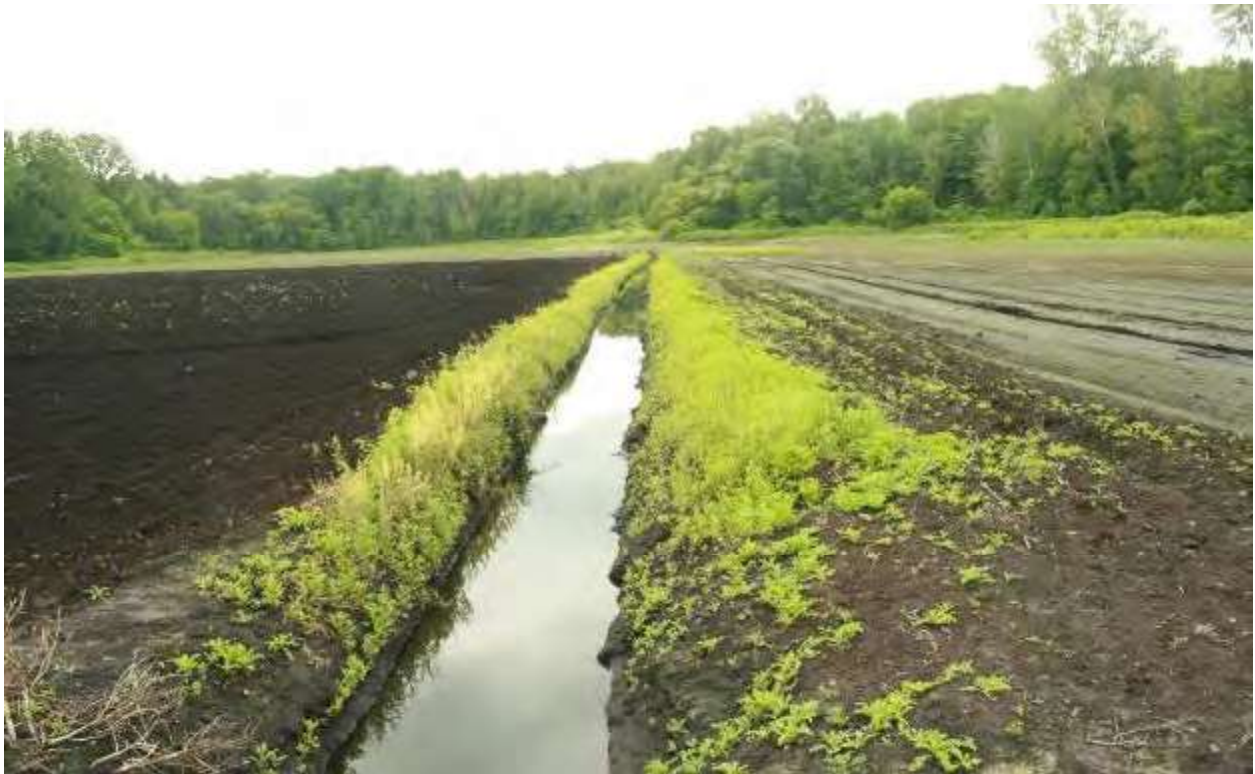
This ditch flows east to west, draining the eastern field into Snake Creek. July 2019. The eastern field is wetter.

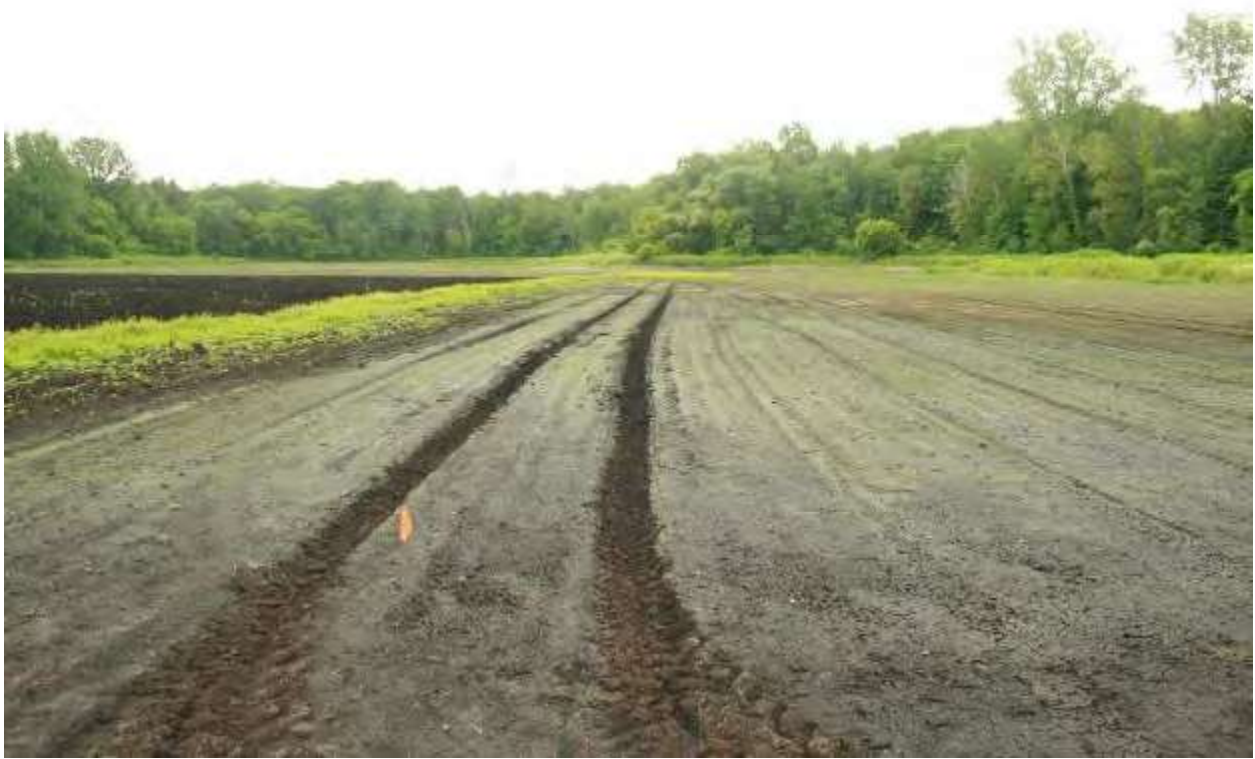
The eastern field washed out in 2019, destroying the onion crop. The ground was still wet, as evidenced by the deep tractor ruts visible in this picture. July 2019.

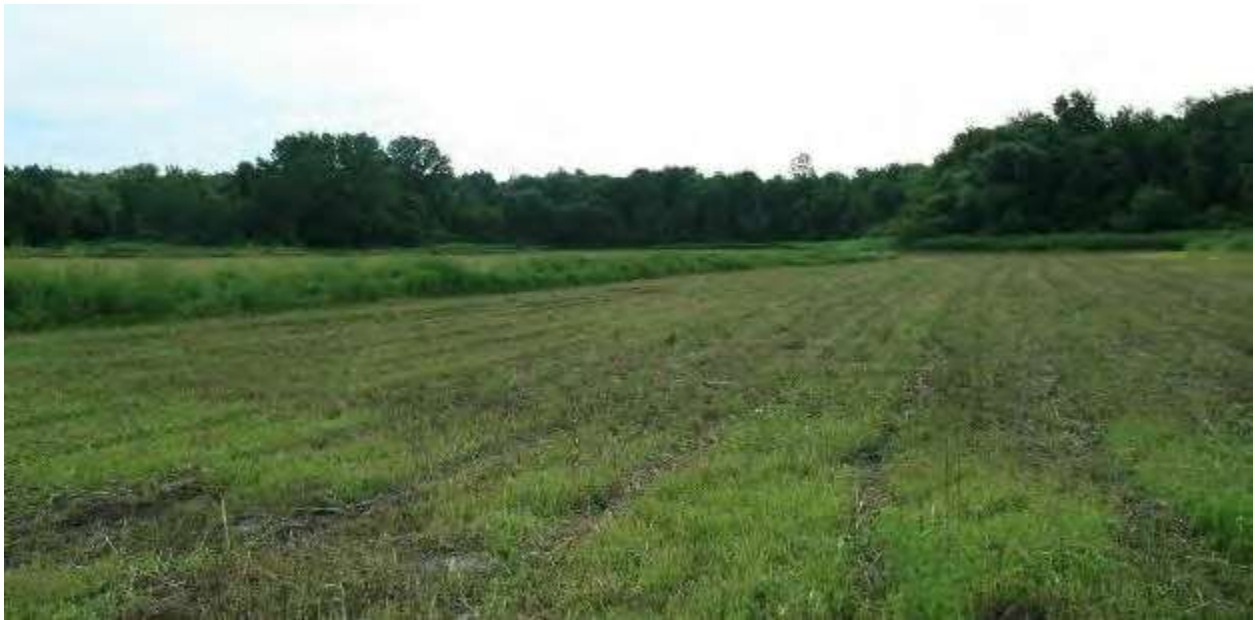
The same eastern field in August of 2020 under drier conditions. The site was mowed to facilitate a topographic survey.

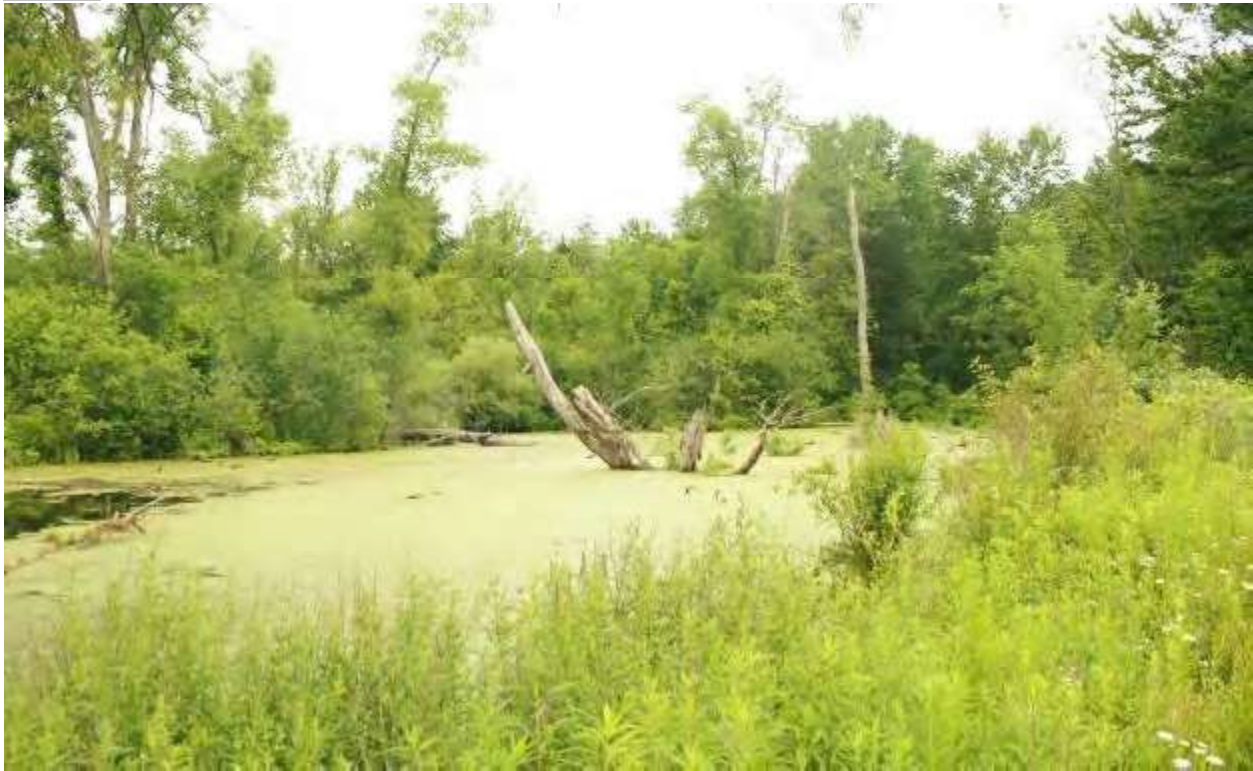
The property also has 2 small forested ponds. Wood ducks, mallards, and Canada geese were seen using them. June 2019.

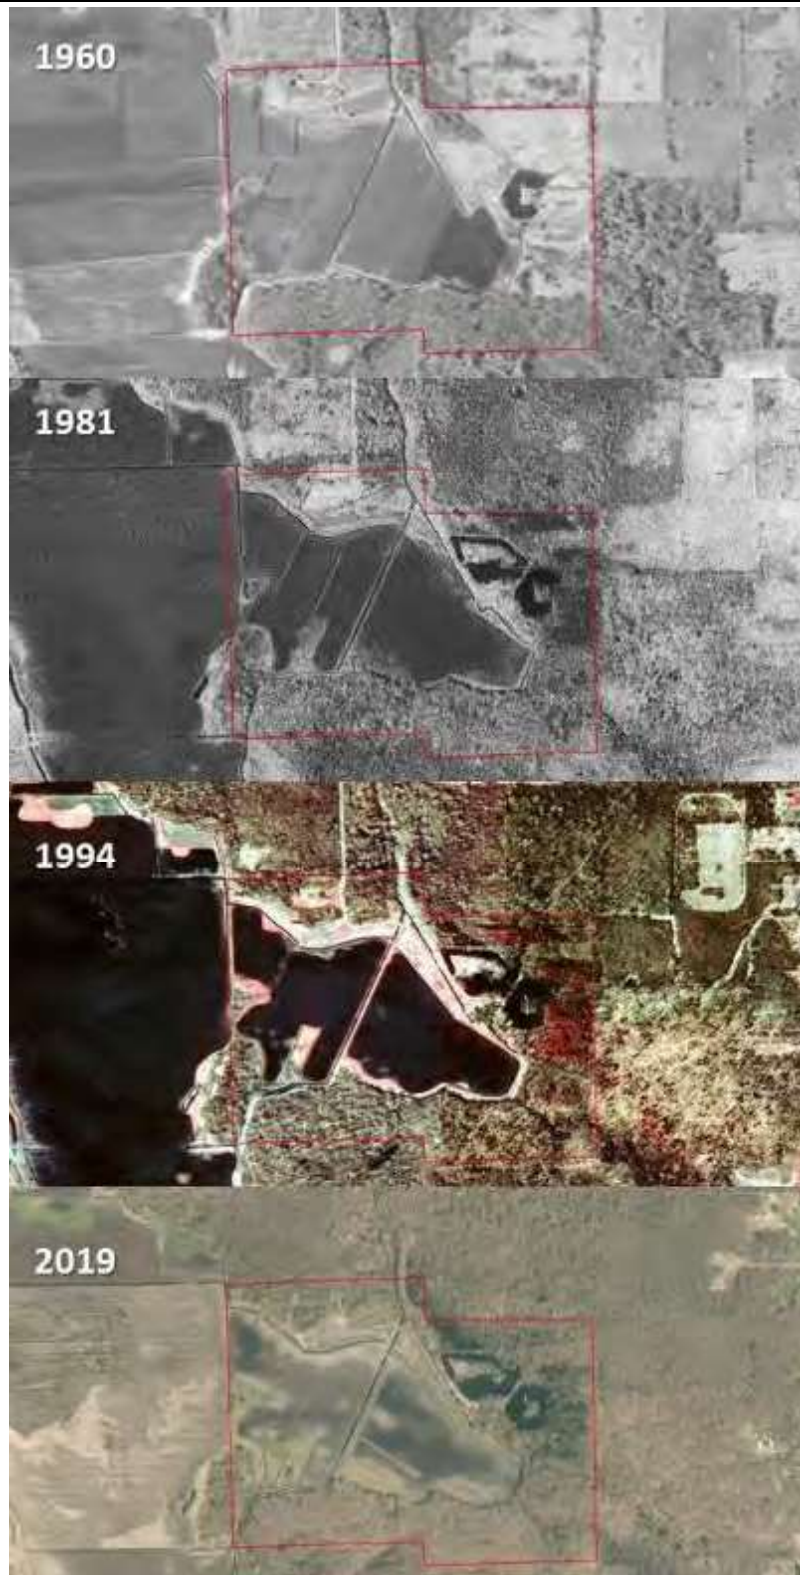
Figure 3 Historical Aerial Photos of Mucky Marsh.

The property has been in agricultural landuse dating back until at least 1960. The Site was actively worked as an onion farm through 2019. The site was mowed in 2020 prior to delineations.

There are no structures on the property. From a review of aerial photography dating back to 1960, fields within the Site have been continuously maintained for agricultural production until the time of acquisition Figure 3. Historic aeriels match with oral history obtained for the site, that subsurface ditches and tiling on the Western Side of the Snake Creek had been reconfigured several times. Some open ditches were no longer present in the 2020's. On-site reviews in June and September 2020 provided evidence of previous hydrological modifications, including ditching and tile drainage, which are apparent in soil conditions and drainage on site. Much of the Site's cropland areas appear to have historically supported more extensive wetlands prior to drainage and tillage activities. The fields were last planted to onions in 2019, and much of that crop was lost to flooding from two flash flooding events. There are no known hazardous material sites located on or within the vicinity of the Site.

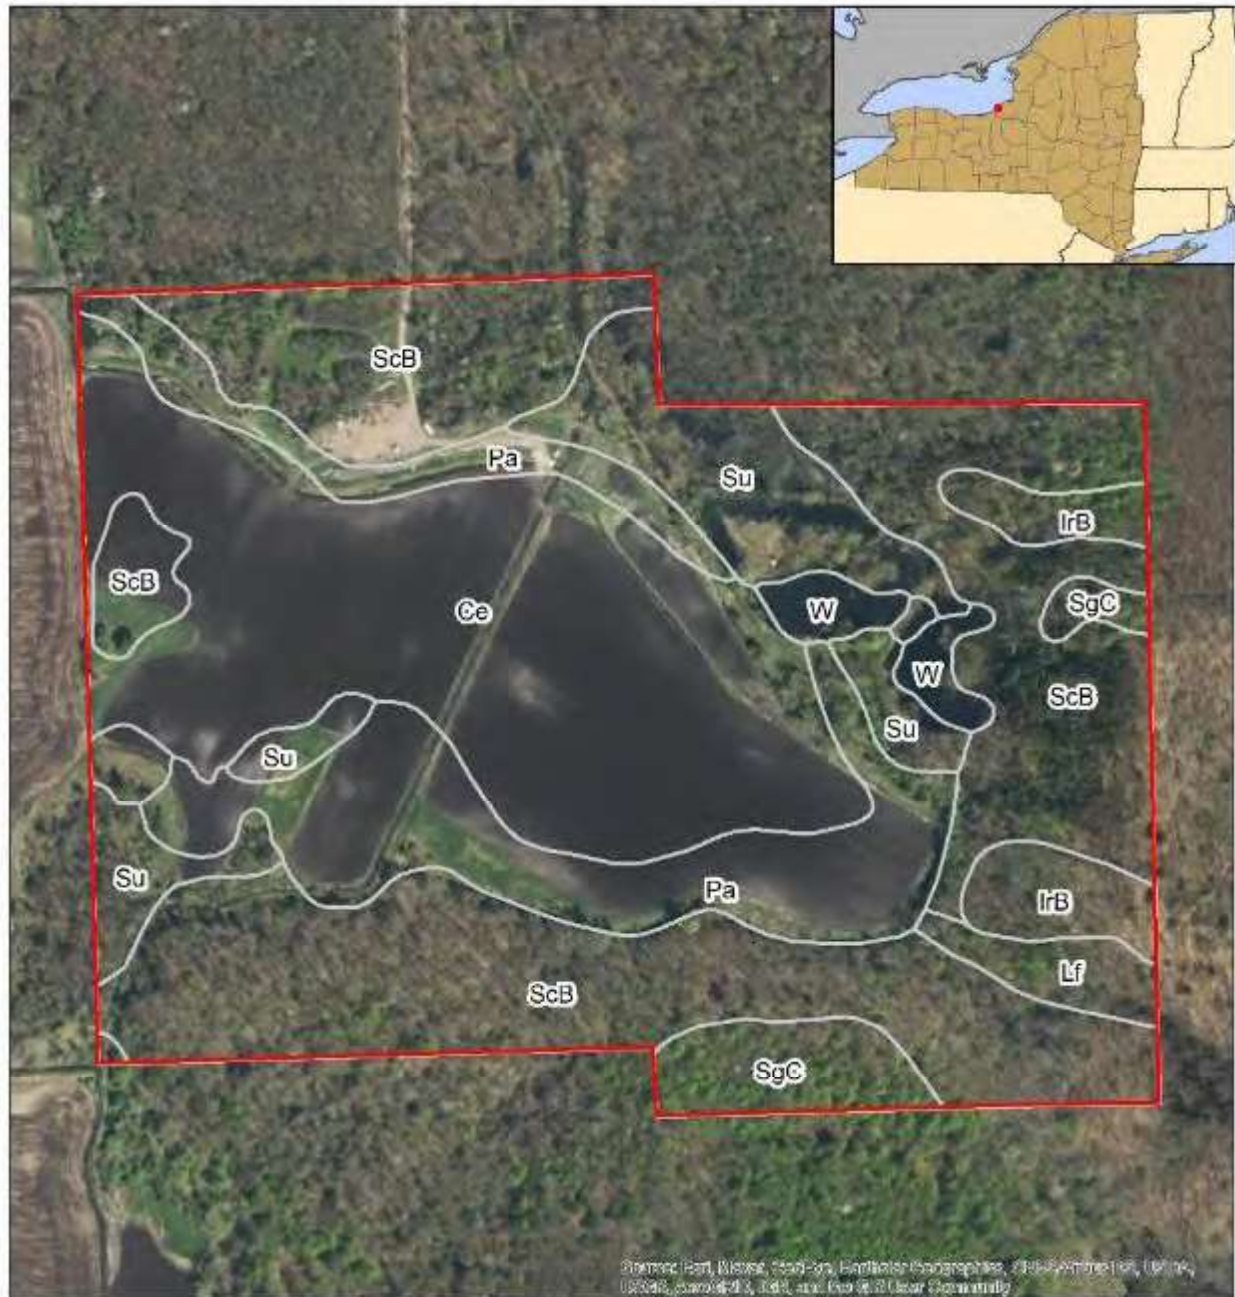
Figure 4 Soils Map.

Restoration activities will occur primarily in Carlisle muck (Ce) and Palms muck (Pa).

Based on the Soil Survey of Oswego County, New York (USDA Official Soil Series Descriptions) the soil series mapped on-site include Carlisle (Ce) and Palms Mucks (Pa), Ira gravelly fine sandy loam (IrB) Scriba gravelly fine sandy loam 0-8% (ScB), Scriba gravelly fine sandy loam, 8 to 15 % (ScC), Sun loams (Su), Lamson very fine sandy loam (Lf). Restoration work will occur primarily in Palms and Carlisle mucks. A soils map is provided in Figure 4. Soil conditions in the field appear to conform to the mapped soil series. Additionally, soil borings were taken throughout areas potentially suitable for restoration work.

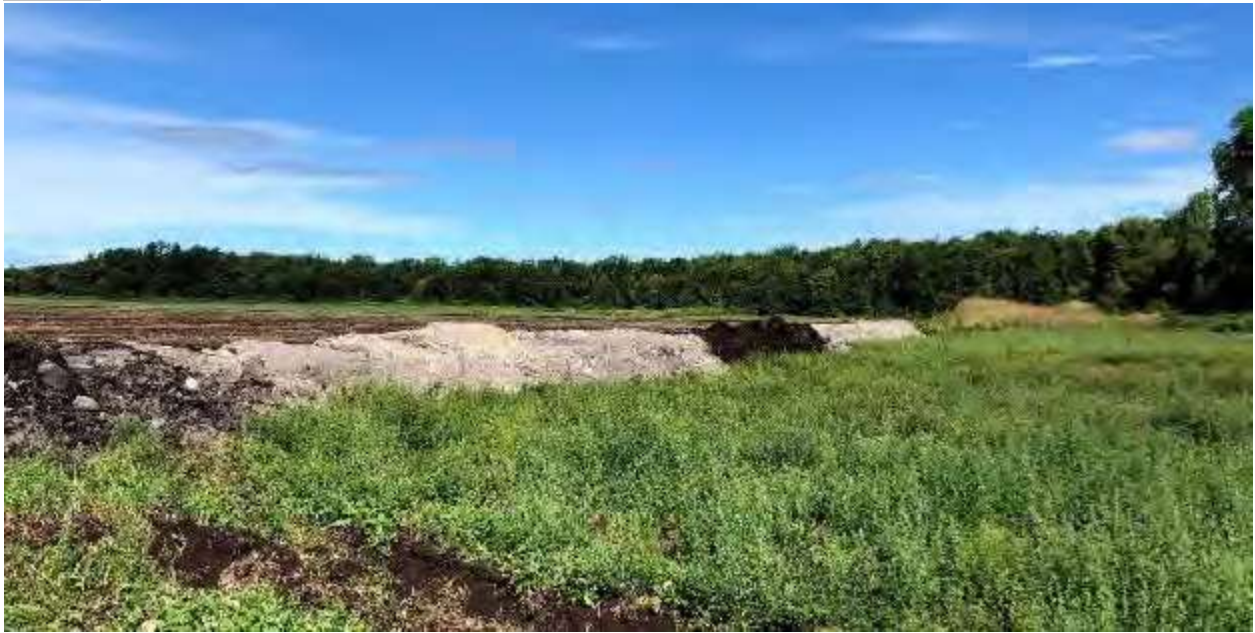
August 26, 2020 shows exposed marl, peat and muck soils exposed on the neighboring parcel to the West where an agricultural operation placed overburden from a ditch near the Western Property boundary of the mitigation site.

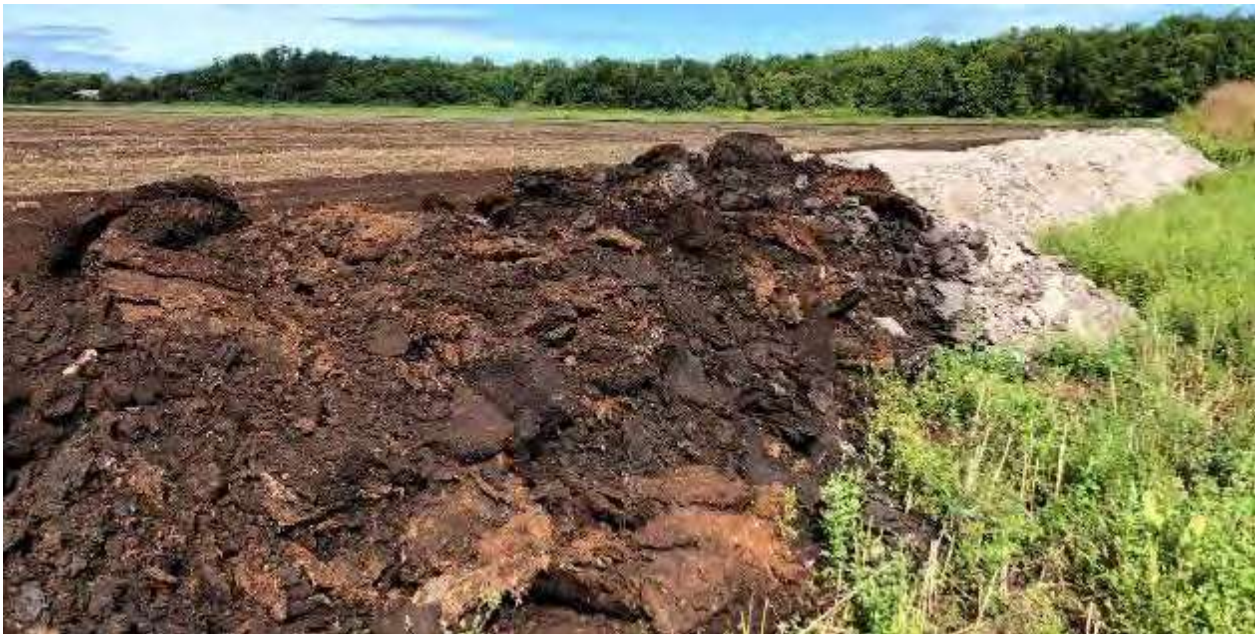
Aug. 26, 2020. Peat soils. Similar soils exist in the project site and are excellent candidates for hydrological restoration.

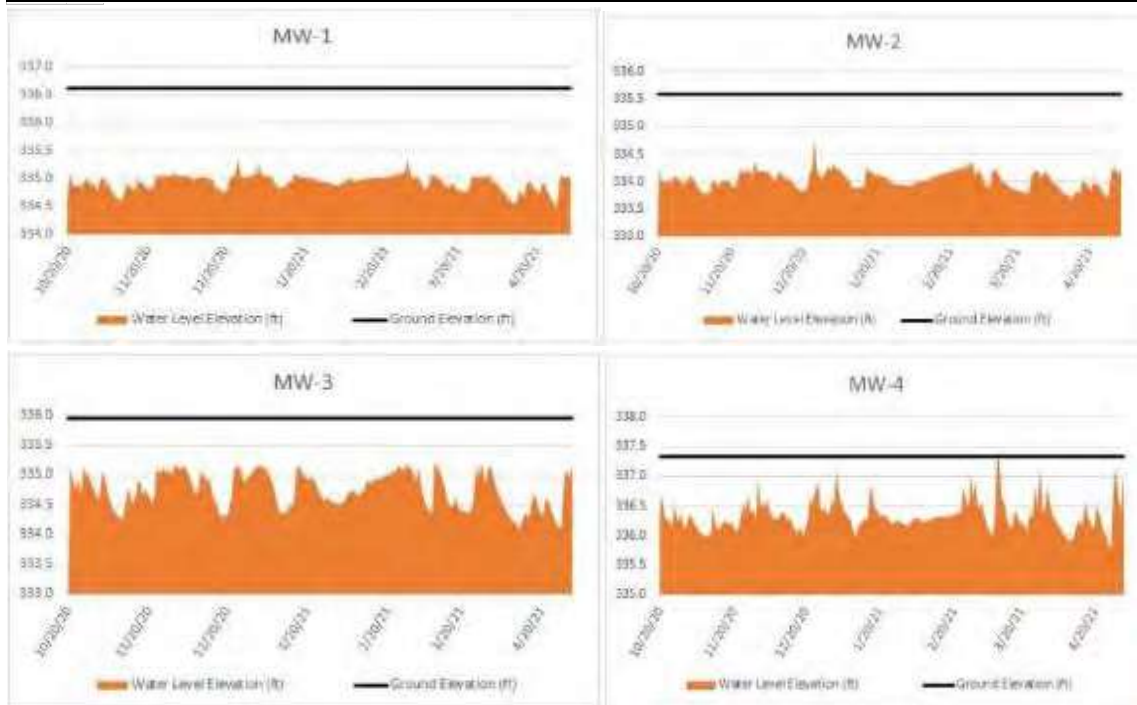
Figure 5 Ground Water Data.

Groundwater data is shown from October 2020 to May 2021. The water-table was often observed within 18" of the surface from fall through spring. Dry conditions in 2020, combined with existing drain tile likely prevented groundwater levels from being closer to the surface.

Rehabilitated areas (Fields 3 and 4) are being monitored with two continuously logging water level monitoring wells which commenced in January 2019 (Figure 5). The temporal record of pre-construction conditions is expected to provide 3 full years of baseline data from which to compare pre-vs. post construction hydrology. This record will be augmented with manual water-level measurements in Fields 1 and 3 to be performed at two additional staff gauge/well locations post-construction. Monitoring locations are shown in Appendix B. Moreover, photo-points included in these areas will provide the ability to qualitatively assess the retention of hydrology compared to baseline conditions to augment quantitative methods.

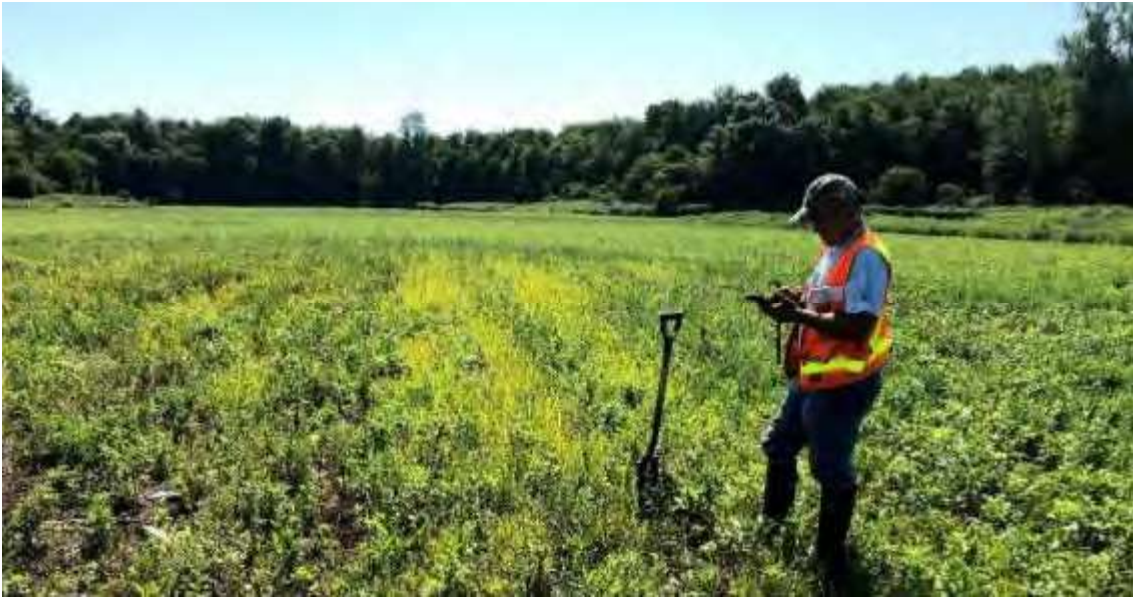
DPW1. Emergent wetland W-A was dominated by yellow nutsedge (*Cyperinus esculentus*) and *Bidens frondosa*. No direct hydrological indicators were present, however the soils met diagnostic conditions for hydrology (depleted below dark surface, muck/peat depth requirements). Pictured Aug. 14, 2020.

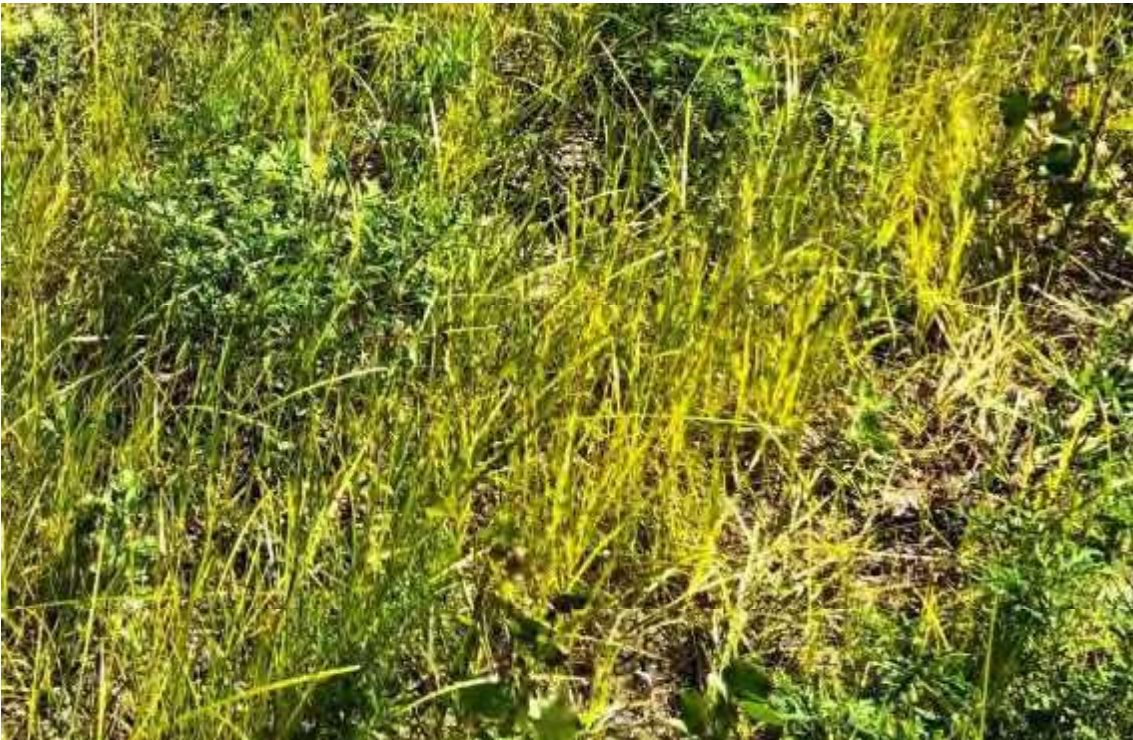
DPW2 W-B Emergent wetland W-A was dominated by yellow nutsedge (*Cyperinus esculentus*) and *Bidens frondosa*. No direct hydrological indicators were present, however the soils met diagnostic conditions for hydrology (depleted below dark surface, muck/peat depth requirements). Pictured Aug. 14, 2020.

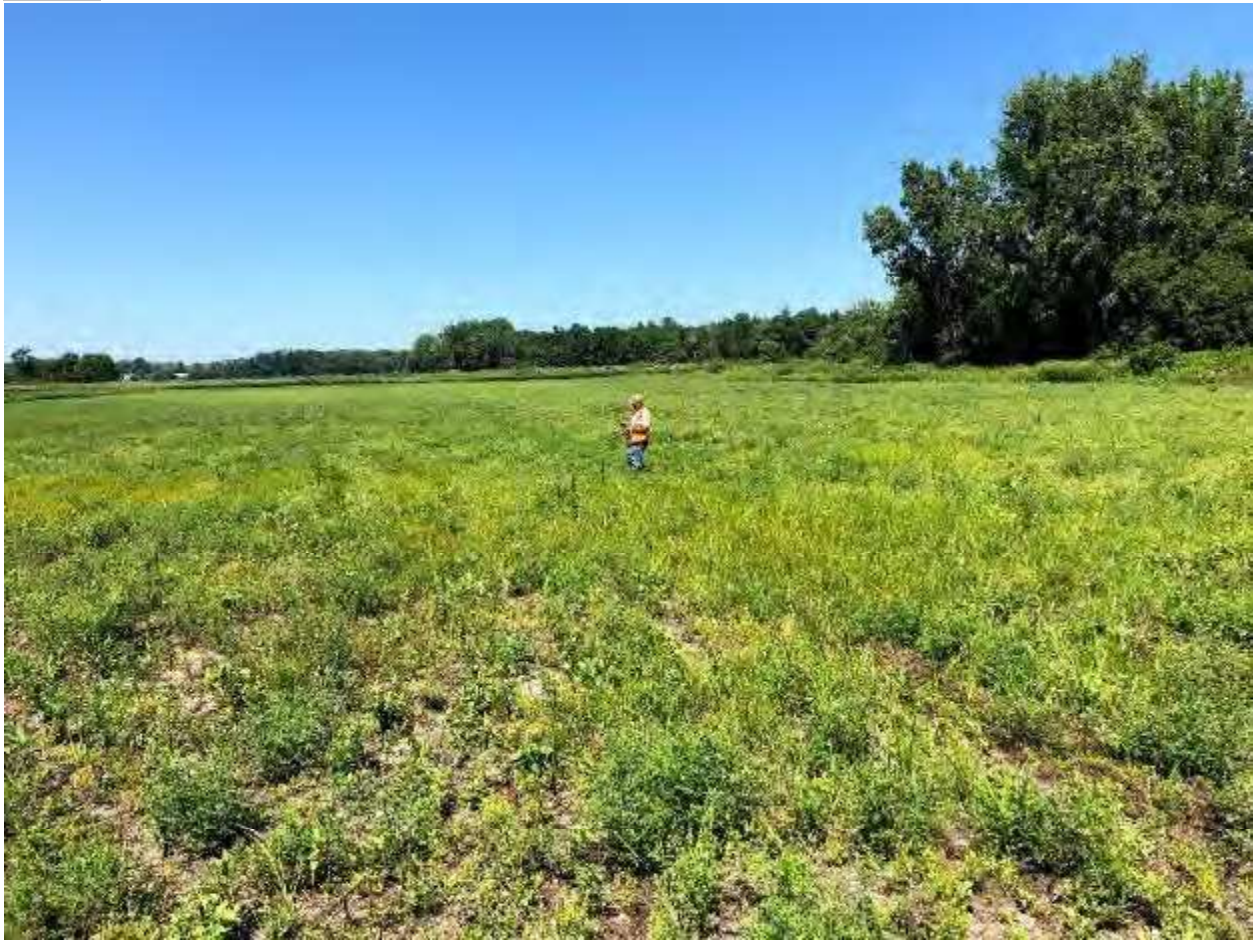
DPW3. This portion of emergent wetland W-C was dominated by *C. esculentus*. Similar indicators to W-A were present. Aug. 14, 2021

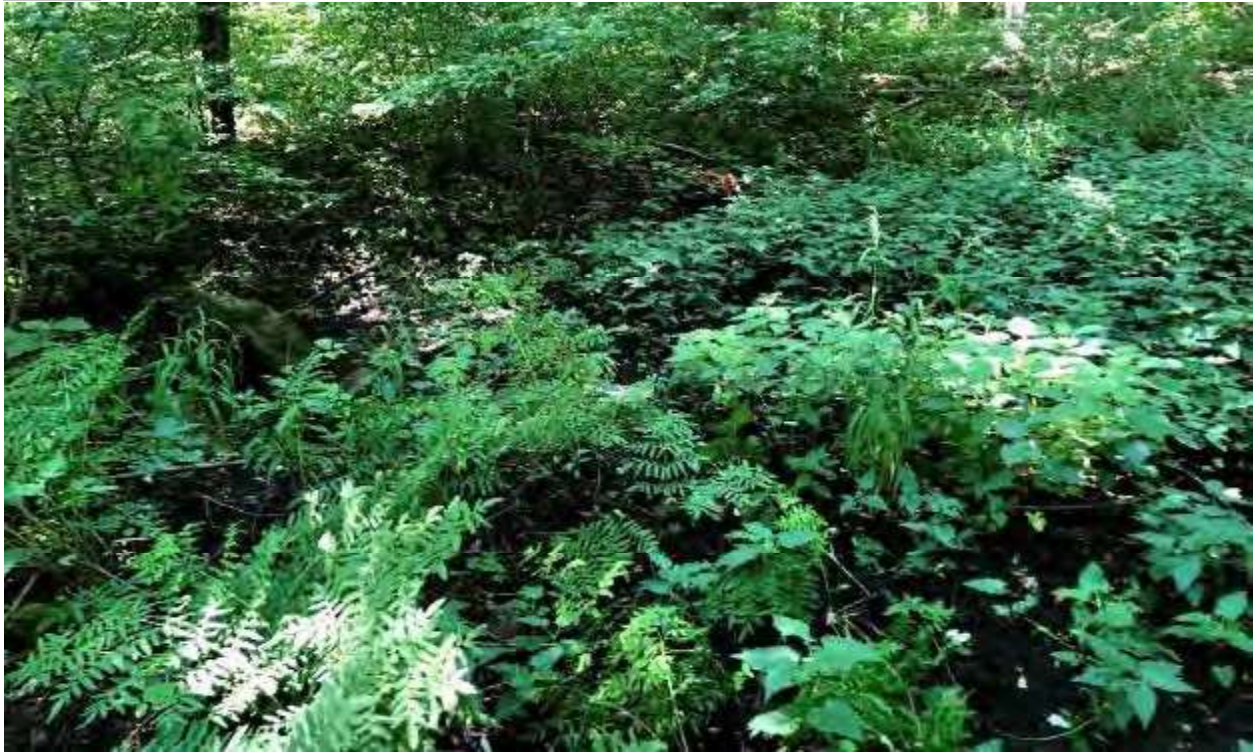
DPW5. Forested wetland W-F had mucky soils with royal fern, lizard tail, and cardinal flower present as hydrophytes. Pictured August 14, 2020.

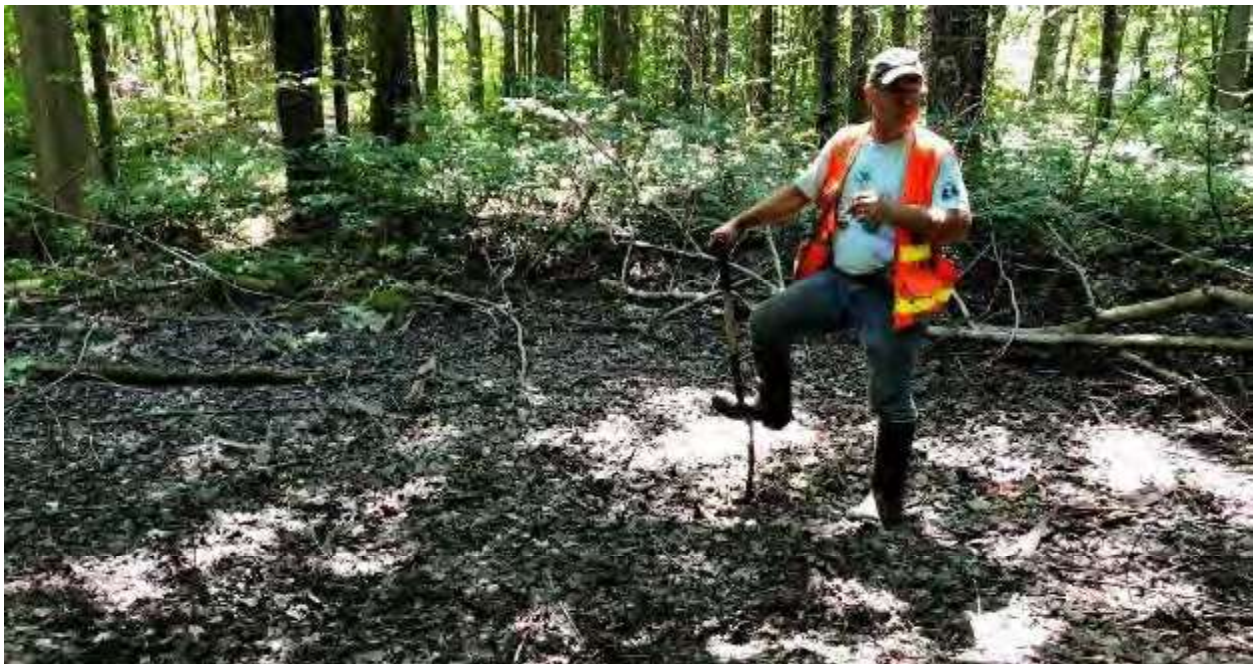
DPW6 Was a vernal pool (W-G) with sparsely vegetated concave surface and no standing water.

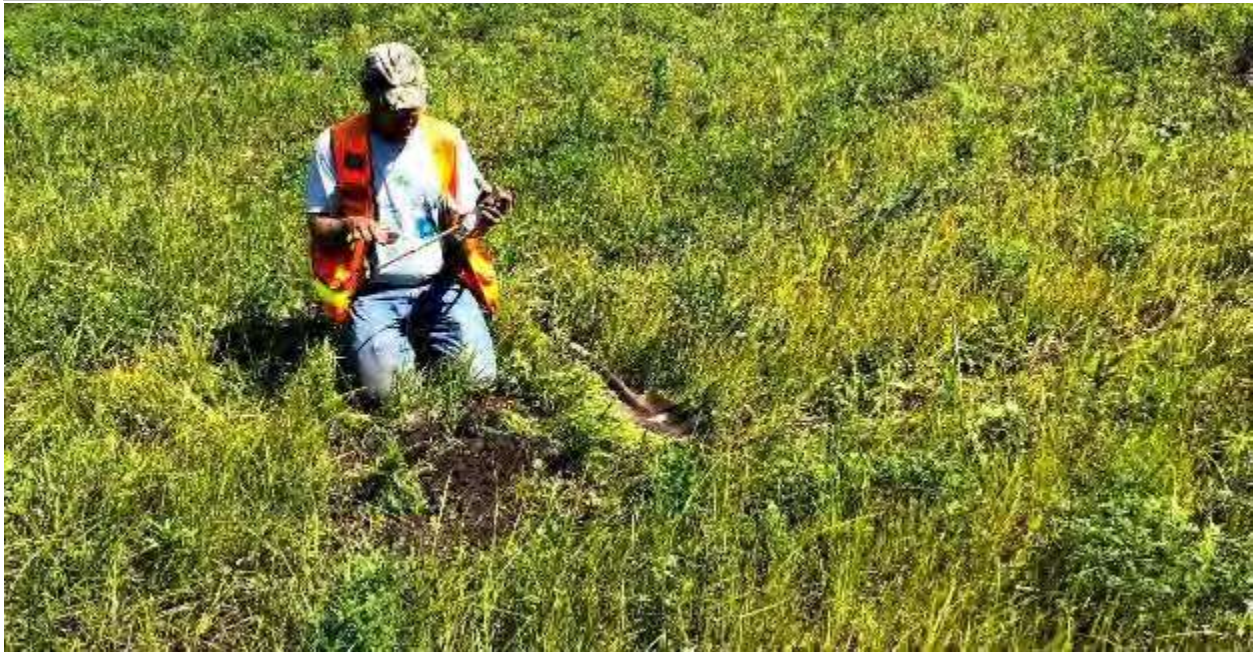
DPW7. Wetland W-E was dominated by common *C. esculentus*. July 2020.

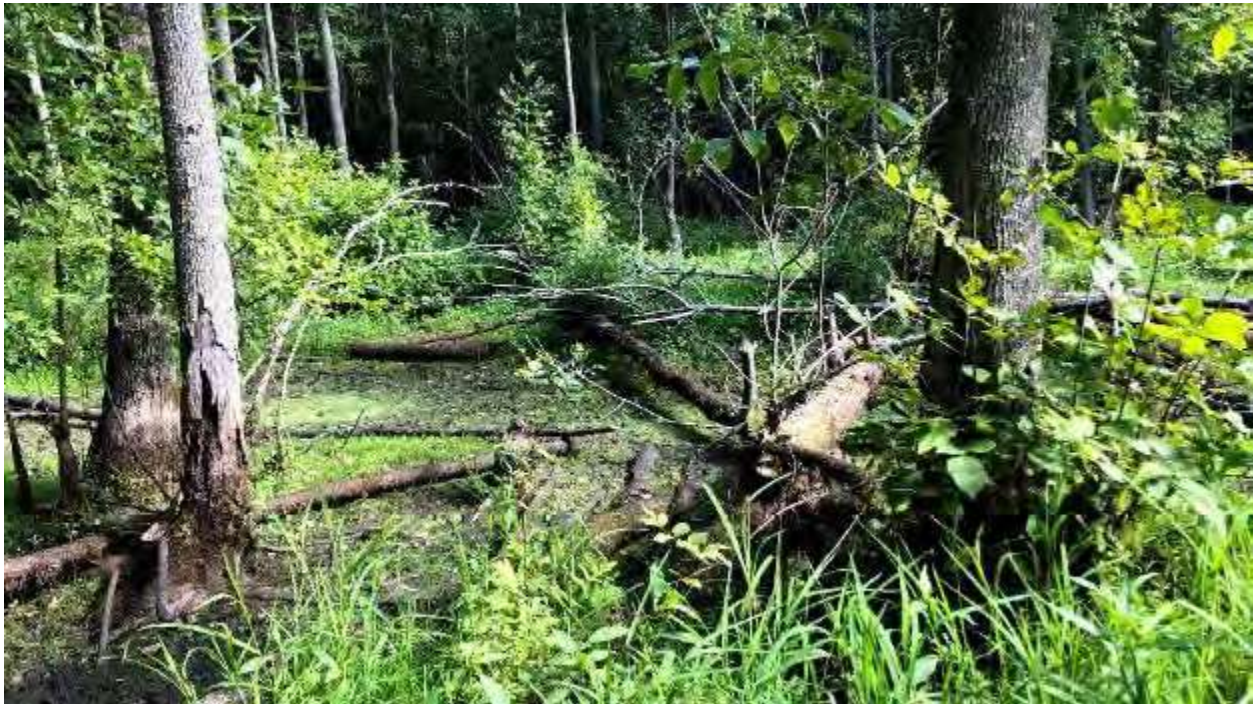
DPW8. This portion of emergent wetland W-H had sparse tree cover <15% and had several emergent hydrophytes including rice cutgrass (*Leersia oryzoides*), *Bidens cernua*, *Carex gynandra*, *Polygonum pennsylvanicum*.

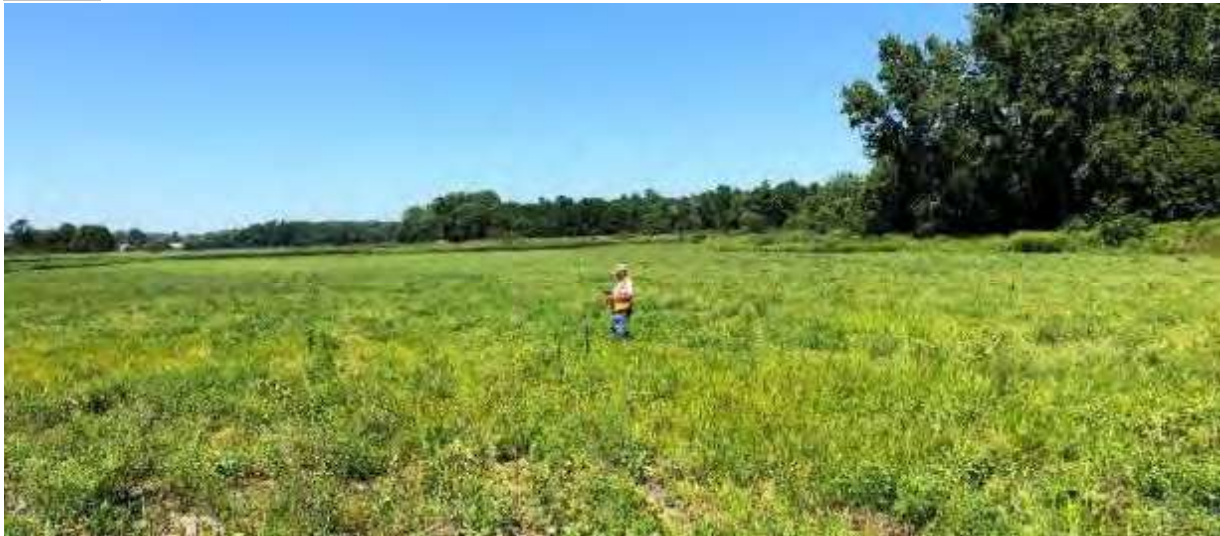
DPW9. Emergent wetland W-8 was dominated by teal love grass (*Eragrostis hypnoides*). Secondary hydrology indicators included geomorphic position and FAC-neutral test. A depleted matrix was the hydric soil indicator.

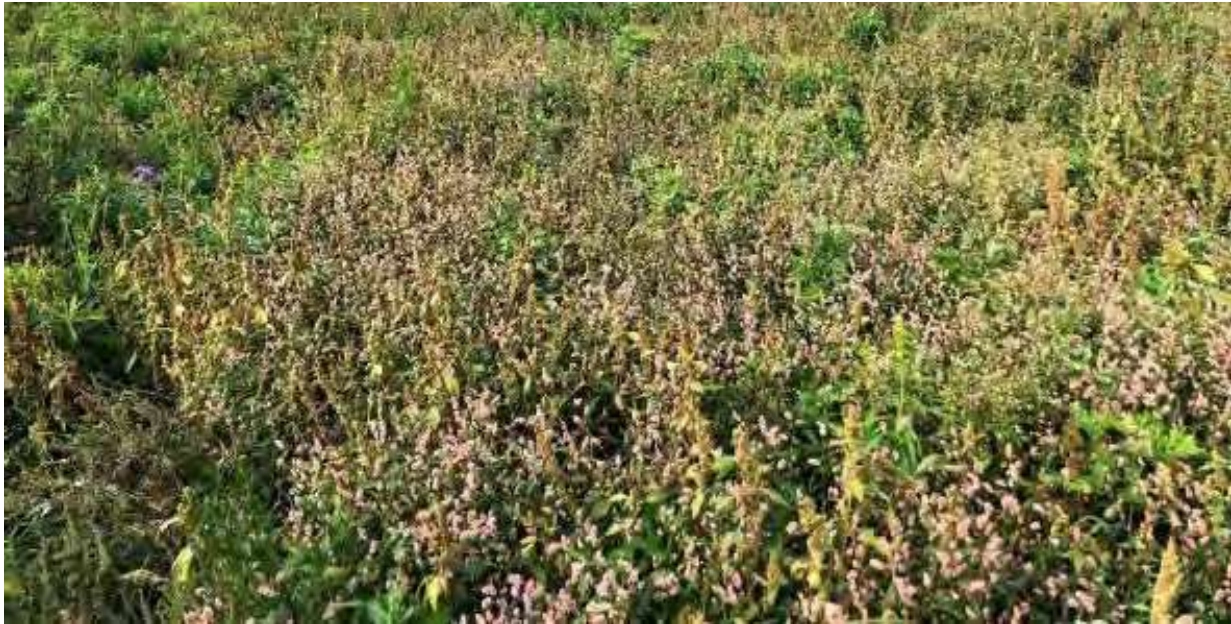
DPW10. Forested wetland W-I was dominated by Pennsylvania Smartweed (*Polygonum pennsylvanicum*).
